Remote assessment of tsunami damage in Japan by means of Google Street View images

Project Report

Jessica Miles and Alan G. Bloodworth

University of Southampton

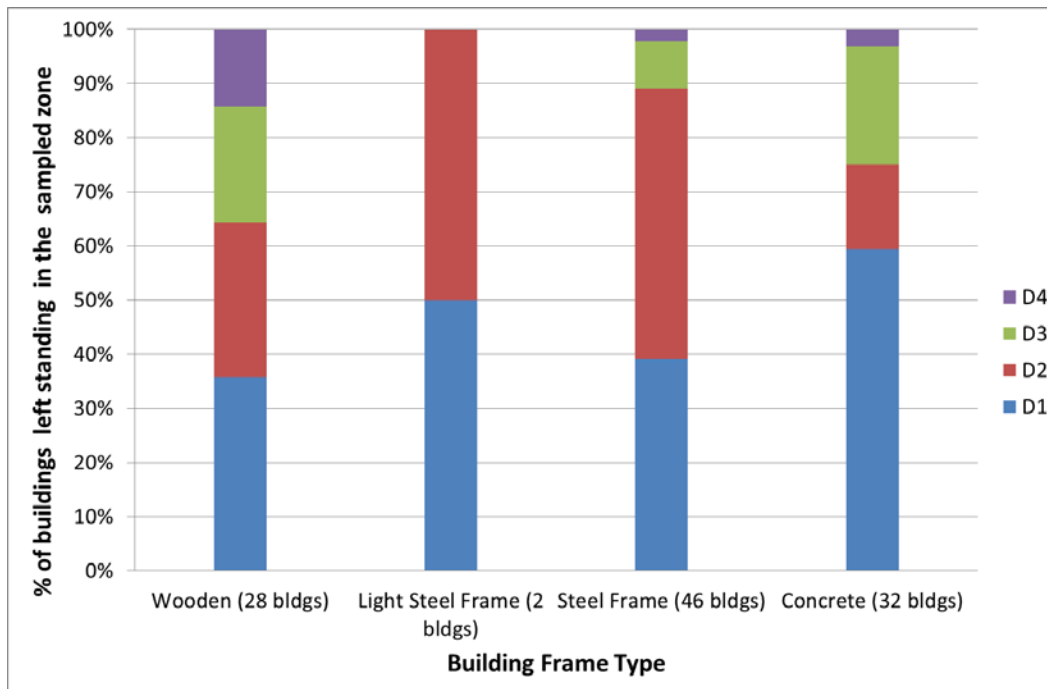
Data for the three sample zones were aggregated for analysis as they showed similar building distributions. Figure 4 shows that timber buildings were most heavily affected, with 36% of those left standing suffering D3 or D4 damage, followed by RC (25%), followed by steel (11%). More data on light steel framed buildings is available from Ishinomaki.

Figure 4 Damage levels by building frame type for Ofunato (aggregated for all sample zones)

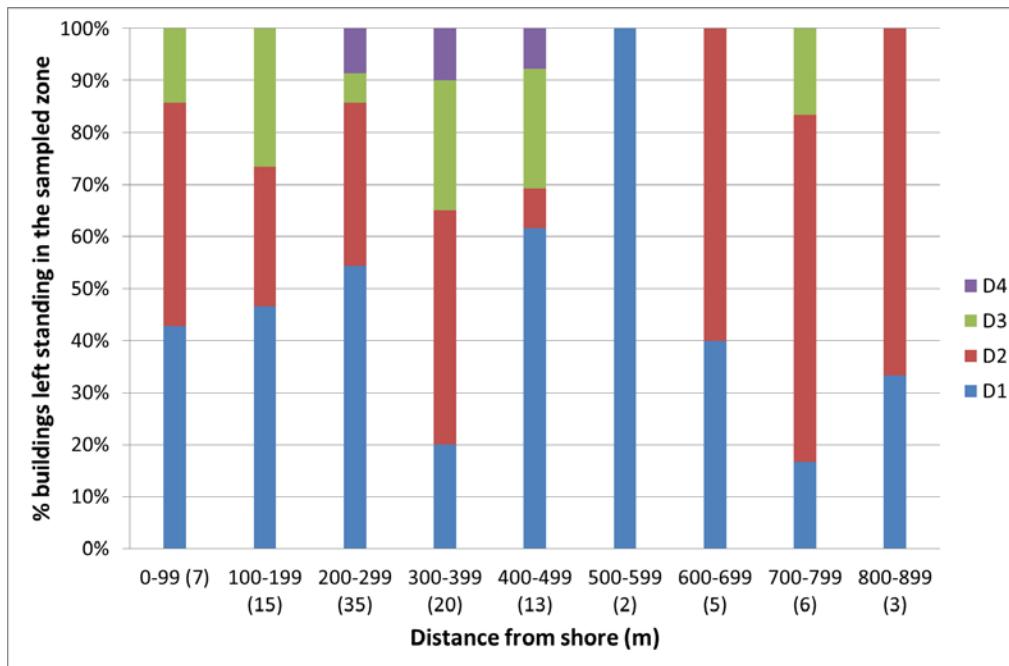
Figure 5 shows damage level with distance from shoreline, for all structure types. Only beyond 500m from the shoreline did the proportion of D3 and D4 buildings decrease (although the number of buildings is small at that distance). In the first 500m there is no clear damage trend, even though as the wave travels inland its speed and energy would be expected to decrease. A possible explanation is that accumulation of debris at the wave front, as noted by eye-witnesses, contributed to damage as the wave moved inland.

Figure 5 Damage levels with distance from shoreline – Ofunato (aggregated for all sample zones and building types, number of buildings at each distance in brackets)

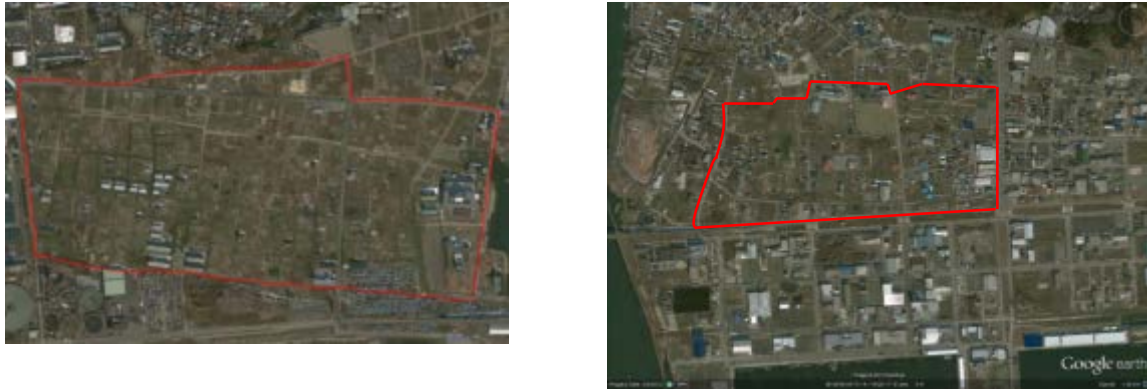
Figure 7 shows the sample zones in more detail after the tsunami. Although both contained mainly residential and small commercial buildings, their situation relative to the shoreline is different, with Area A in close proximity but Area B set back about 400m behind the port. Area A experienced approximately 91% obliteration of buildings compared to 68% in Area B. This is likely to be due to shielding by the port area that was densely filled with large industrial steel framed buildings, many of which remained standing to some extent.

Figure 7 Ishinomaki: Area A 'After' - 03/04/12 (Google Earth, 7.0, 2012b) (left), Area B 'After' - 03/04/12 (Google Earth, 7.0, 2012c) (right)

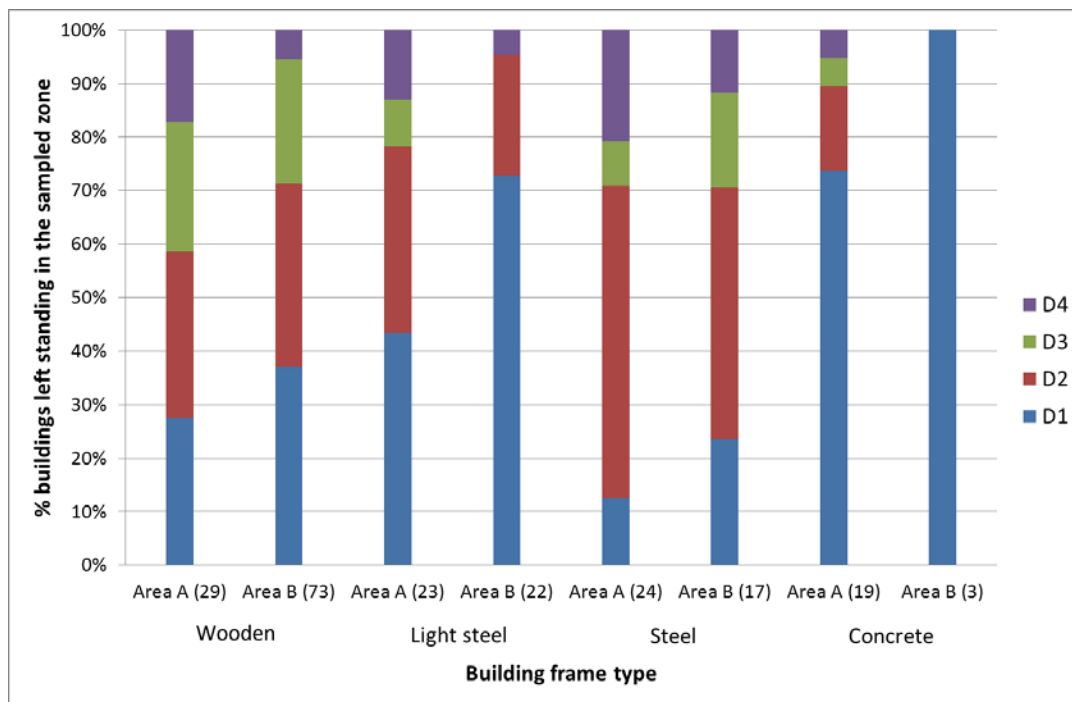
From the relationship between structure type and damage categories (Fig. 8) it can be seen that as the strength of the building frame increases (from timber to light steel to RC), damage severities decrease. Light steel performed better than timber. There is an unexpected trend of greater damage to steel-framed buildings, where it was noted that 61% of surveyed buildings suffered partial or complete loss of cladding and subsequent damage to the non-structural components of the building. 42% of steel buildings were commercial/industrial with light panel cladding, which proved to be insufficiently robust against the tsunami impact.

Figure 8 Damage levels by building frame type for Ishinomaki (Areas A and B) (number of buildings of each type in brackets)

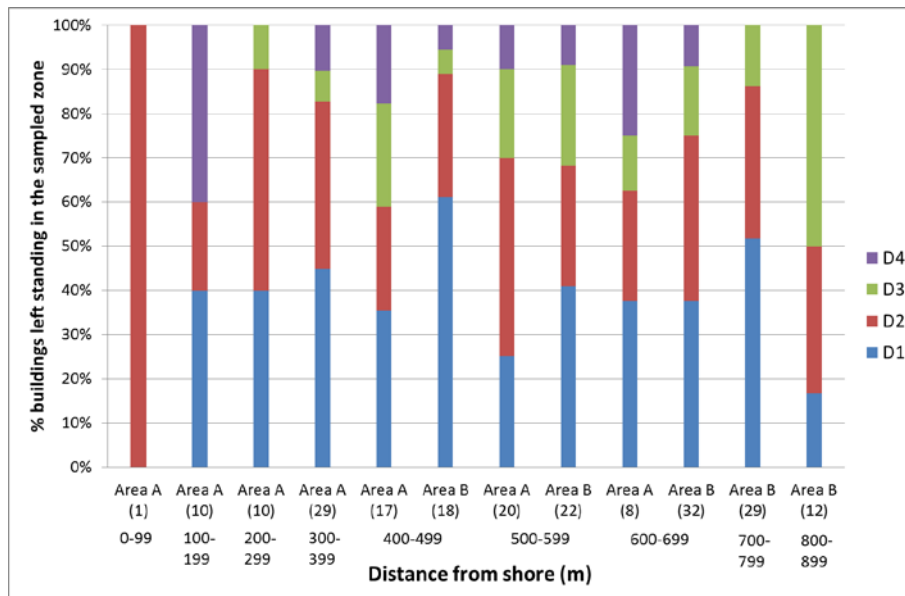
Thus, although lighter construction forms such as timber and light steel do not survive well under tsunami impact, the noticeably better outcome in Area B (Fig. 9) suggests that positioning major infrastructure and larger structures on the shoreline can significantly improve performance in zones inland.

Figure 9 Damage levels with distance from shoreline – Ishinomaki (Areas A and B)

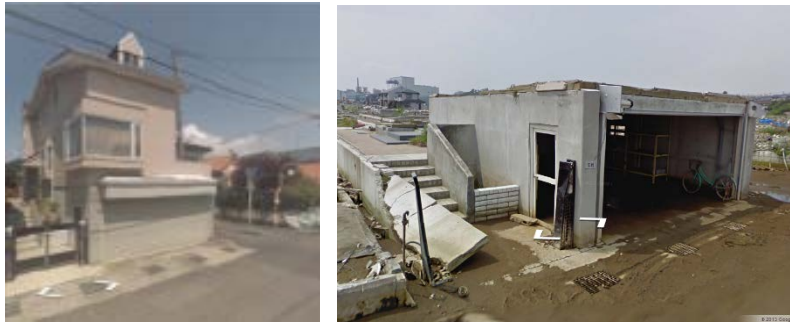
Dual Frame Construction is a noticeable design feature of housing in Ishinomaki, where a number of buildings remained standing with an RC or steel-framed ground floor and timber-framed construction for the upper floors (Fig. 10). The ground floor was often used as a garage, or sometimes commercial space in a mixed-use structure. In Ishinomaki, the inundation height was equivalent to two storeys and in the majority of cases observed, the RC/steel ground floor survived virtually undamaged, while the timber upper floors were heavily damaged or washed away (suggesting insufficient strength or connection to the ground floor frame). These buildings performed better overall than pure timber frames that were either completely destroyed or suffered collapse of the ground floor. This was also noted by EEFIT (2011, p101), referring to them as ‘raised dwellings’.

Figure 10 Dual frame construction building A25 in Ishinomaki ‘Before’ (GSV, 2013d) (left) and ‘After’ (GSV, 2013c) (right)

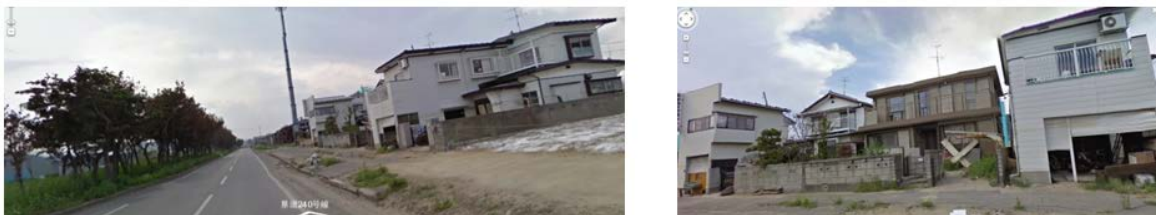
Sheltering by trees. A group of small commercial and residential structures of light frame construction (probably timber) were identified with damage rating D1, 435m from the shoreline in Area B (Fig. 11). Behind and to the right when viewed from the shore, very few buildings were left standing or not heavily damaged. The only clear reason for this group of buildings’ survival is sheltering from a line of trees still standing directly in front of them, between the residential area and the port. These trees relied in turn on a degree of sheltering from the port area buildings, as trees at other locations along the shorefront were uplifted from their roots and did not survive the tsunami.

Figure 11 Buildings in Area B behind the port in Ishinomaki showing evidence of sheltering by trees (GSV, 2013c)

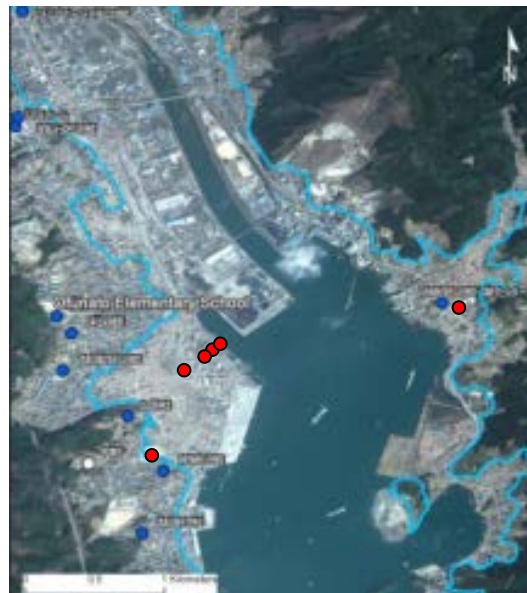
from the survey to be potential multi-purpose VE Shelters (Fig. 12) as they were steel or RC framed, three or more storeys in height with damage level D1. Locations ranged from 65-450m from the shoreline, contrasting with the city's designated shelters, all but one of which were positioned outside the inundation zone indicated by the blue line in Figure 12.

Figure 12 Locations of possible multi-purpose VE shelters (shown in red) within inundation zone at Ofunato, superimposed on map of designated VE shelters (in blue) (IIS, 2011)

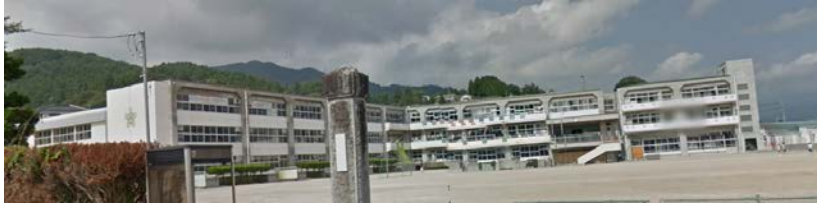
Ofunato Elementary School is a three storey RC structure (Figure 13), located 490m from the shoreline with damage level D0. The school is well positioned on higher ground to serve as a shelter. Schools are commonly designated as VE shelters in Japan because they are built to high seismic standards and have capacity for large numbers of evacuees.

Figure 13 Potential VE Shelter: Ofunato Elementary School (GSV, 2013b)

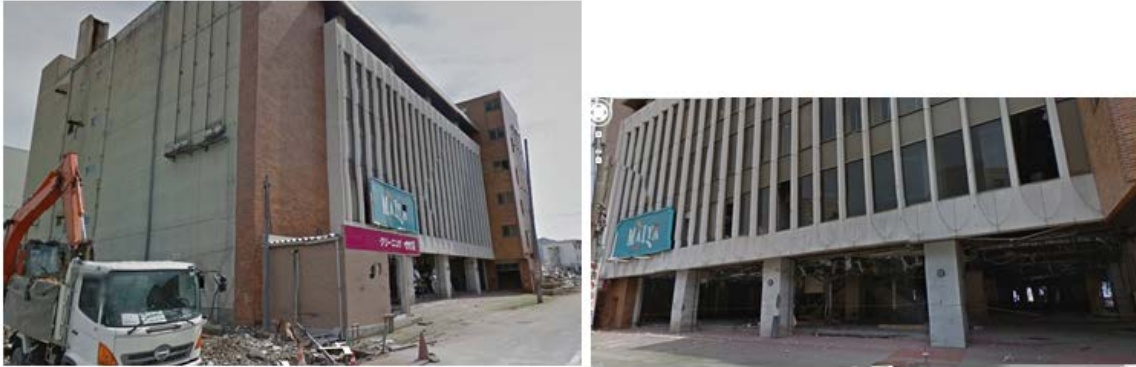
The five-storey steel-framed Maiya Shopping Centre was at the forefront of the tsunami, 100m from the coastline, yet survived with damage level D2 (Figure 14) despite inundation to third floor level (9m). Under FEMA guidelines, it had sufficient height to serve as a shelter. The ground floor is relatively open (serving as a customer car park), allowing water to pass through. This was also the case with an open plan construction car park directly in front of the shopping centre that suffered damage D1.

Figure 14 Potential VE Shelter, Ofunato: Maiya Shopping Centre (GSV, 2013b)

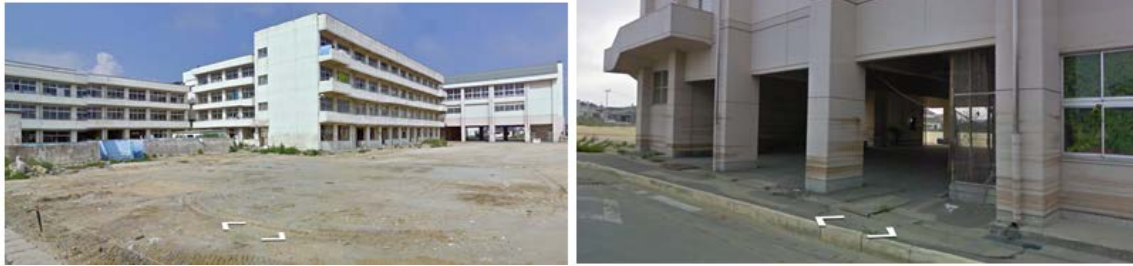
Minati Junior High School is located 750m from the shore and suffered damage D1. The size of the structural columns suggests the school is RC construction (Figure 15). Parts of the ground floor are open plan, used for car parking, and the school has a number of external staircases (possibly fire escape routes) to the uppermost floors that would enable evacuees in the surrounding houses readily to use it as a VE Shelter.

Figure 15 Potential VE Shelter, Ishinomaki: Minati Junior High School (GSV, 2013c)
